Feet	ISSUED FOR: AMERICAN ENERGY CORPORATION	LONG RUN STREAM RESTORATION AREA CENTURY MINE AMERICAN ENERGY CORPORATION BELMONT COUNTY, OHIO	
CHECKED BY: JAI	Legend

CIVIL & ENVIRONMENTAL CONSULTANTS, INC. 333 Baldwin Road Pittsburgh, PA 15205-9702 1-800-365-2324 www.cetnc.com		
APPROVED BY: MRH*				
SCALE: 1" = 200'				
DATE: 11/23/2010	*Hand Signature on File		PROJECT NO.: 101-869 FIGURE: 4

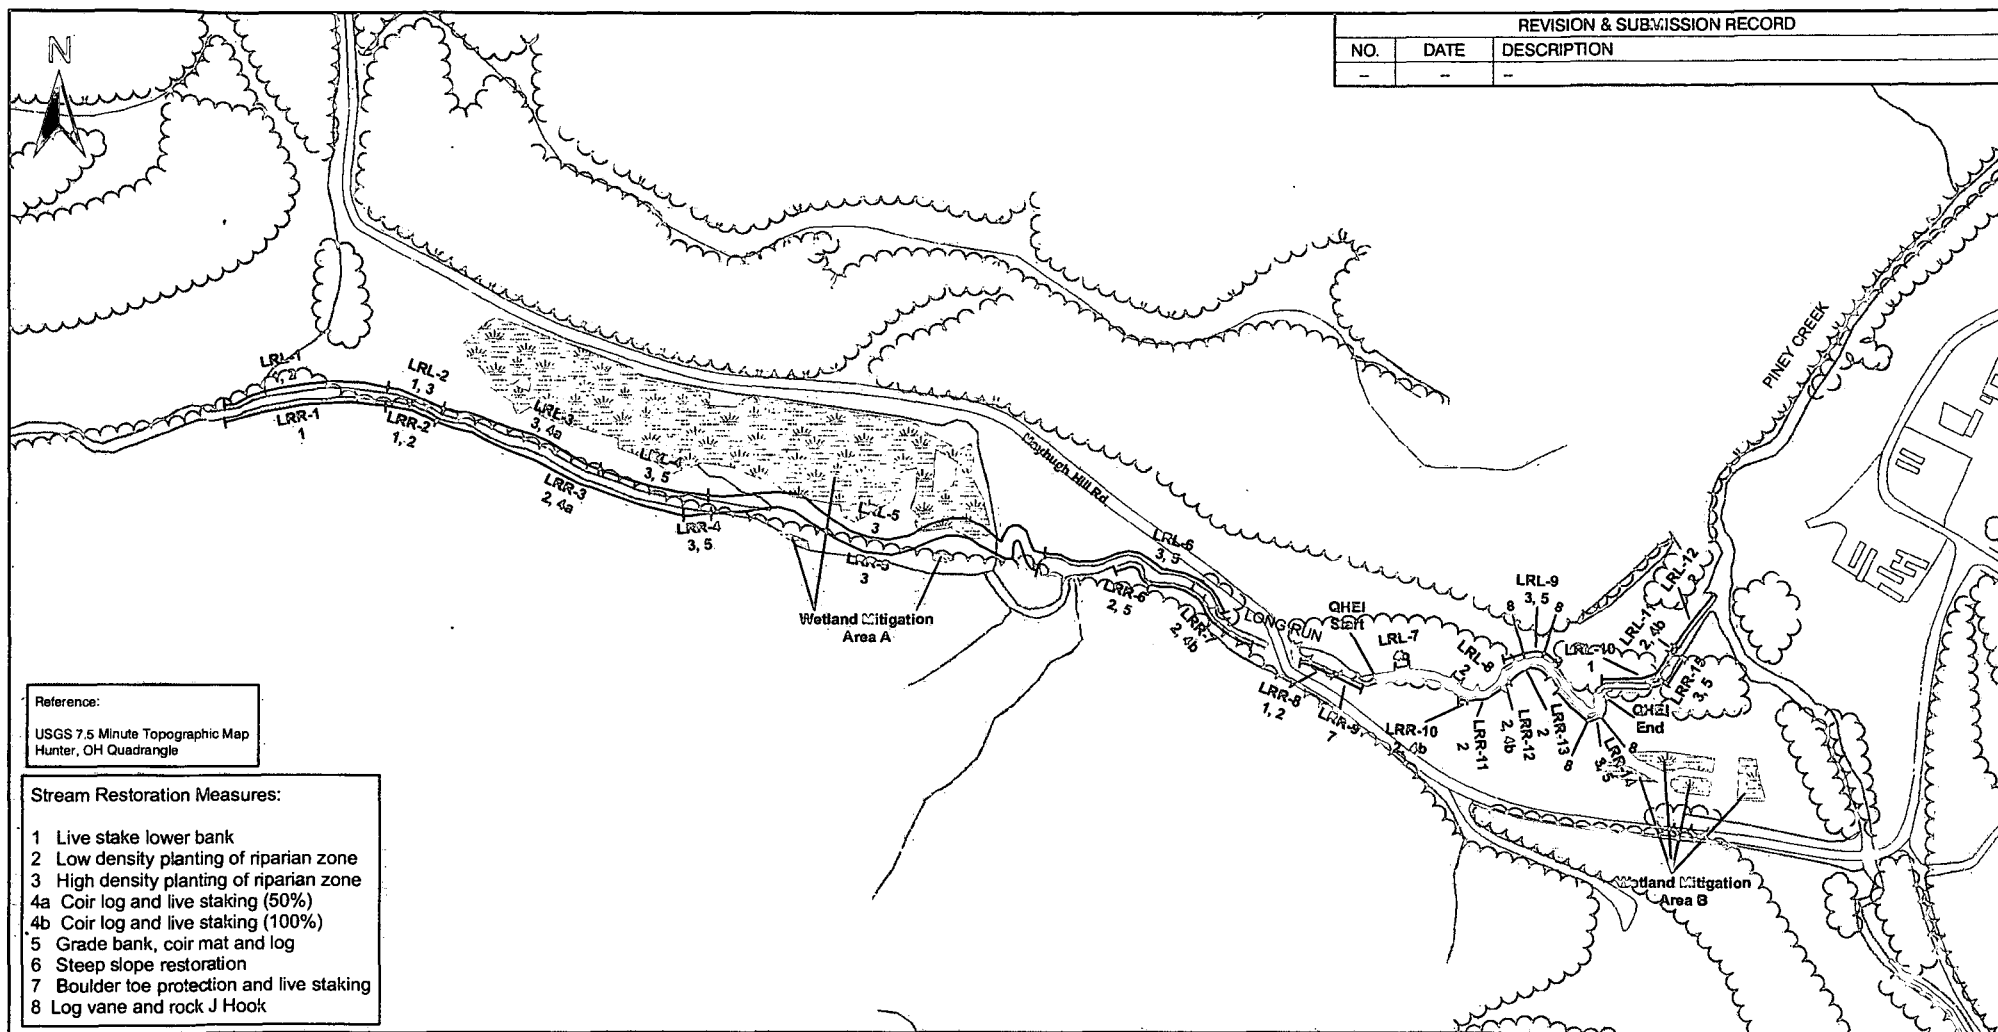
- Stream Restoration Measures:**
- 1 Live stake lower bank
 - 2 Low density planting of riparian zone
 - 3 High density planting of riparian zone
 - 4a Coir log and live staking (50%)
 - 4b Coir log and live staking (100%)
 - 5 Grade bank, coir mat and log
 - 6 Steep slope restoration
 - 7 Boulder toe protection and live staking
 - 8 Log vane and rock J Hook

Qualitative Habitat Evaluation Index Reach LRR-4 Reach Designator 3, 5 Restoration Measure	ISSUED BY:
